## **BOLTED STRUCTURAL CONNECTIONS IN FIBERGLASS MATERIALS**

## **ABSTRACT:**

This paper compares several methods of connecting fiberglass reinforced pultruded plastic (FRP) structural members to tubular sections using bolted designs that are commonly used in the cooling tower industry. The study compares theoretically predicted values with full-scale actual laboratory test results.

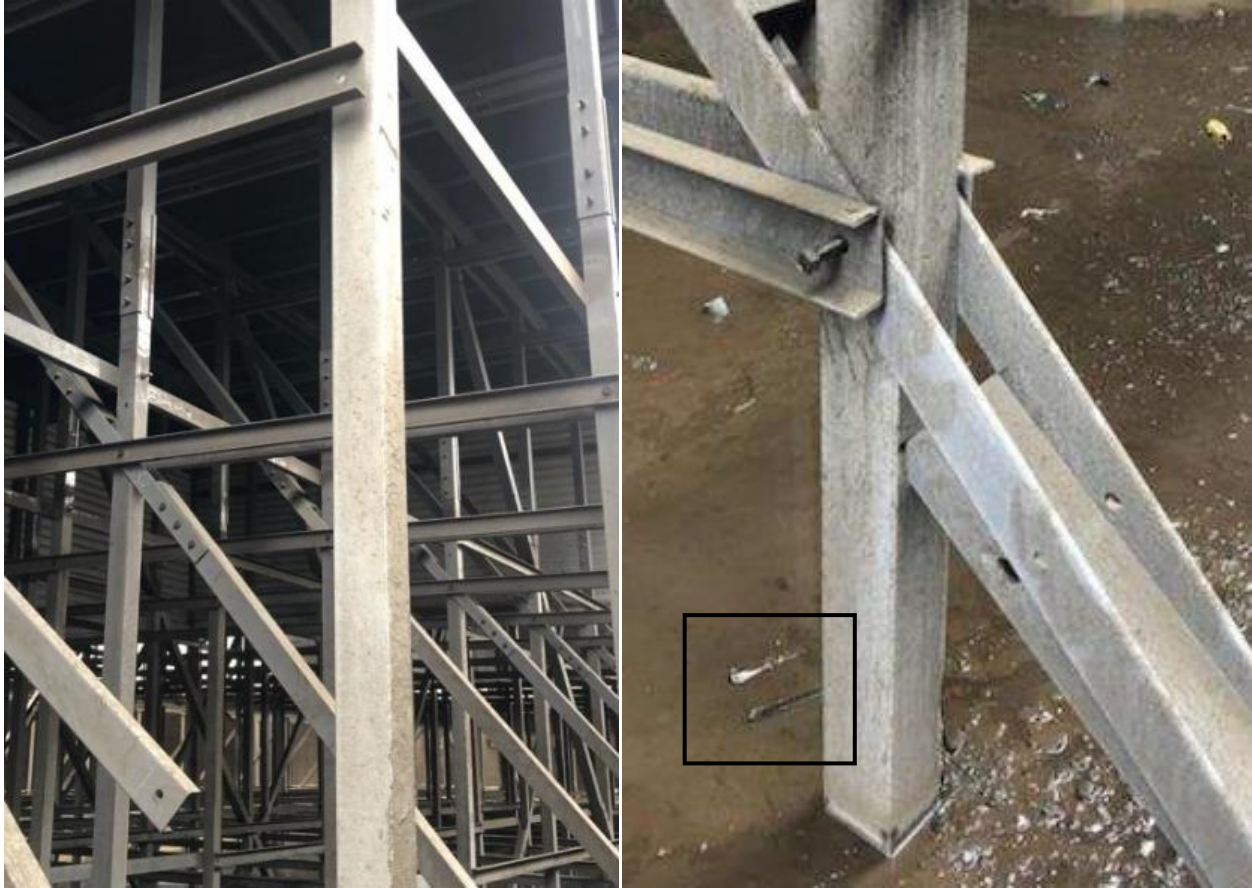
Figure 2 shows examples of such disorders at one recently-inspected site. Alarming, this follow-up inspection was done less than six months after its initial installation. The photos shown in Figure 2 are not isolated cases within this large installation. More disturbingly, this condition is commonly the case found during many tower inspections.<sup>(14)</sup>

**FIGURE 2**  
**LOOSE AND MISSING BOLTS FOUND DURING SITE INSPECTION**

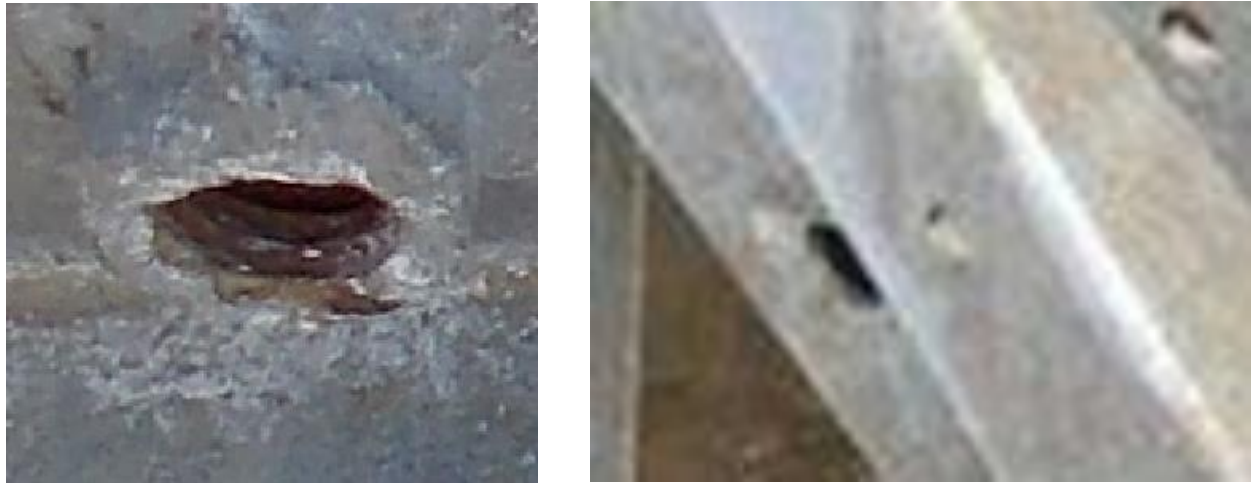
Even more importantly, however, pinned connections cannot, by definition, contribute any torsional moment resistance needed for structural stiffness against the fatigue loading from the shifting cyclical compressive and tensile forces existing in the diagonal members. Practical joints are rarely loaded in pure shear or tension. Indeed, field inspections of FRP towers that have been in service for several years with pinned connections shows clear indication that the clearance holes of pinned FRP connections have elongated from cyclic wear, particularly near the top of the tower where deflections are greatest.<sup>(14)</sup> Figure 3 shows two such examples. Note

that the bolt thread pattern is worn into the hole in the picture on the left. The hole on the right had been dramatically elongated before the bolt fell out.

**FIGURE 3**  
**DAMAGED BOLT HOLES OF PINNED CONNECTIONS**

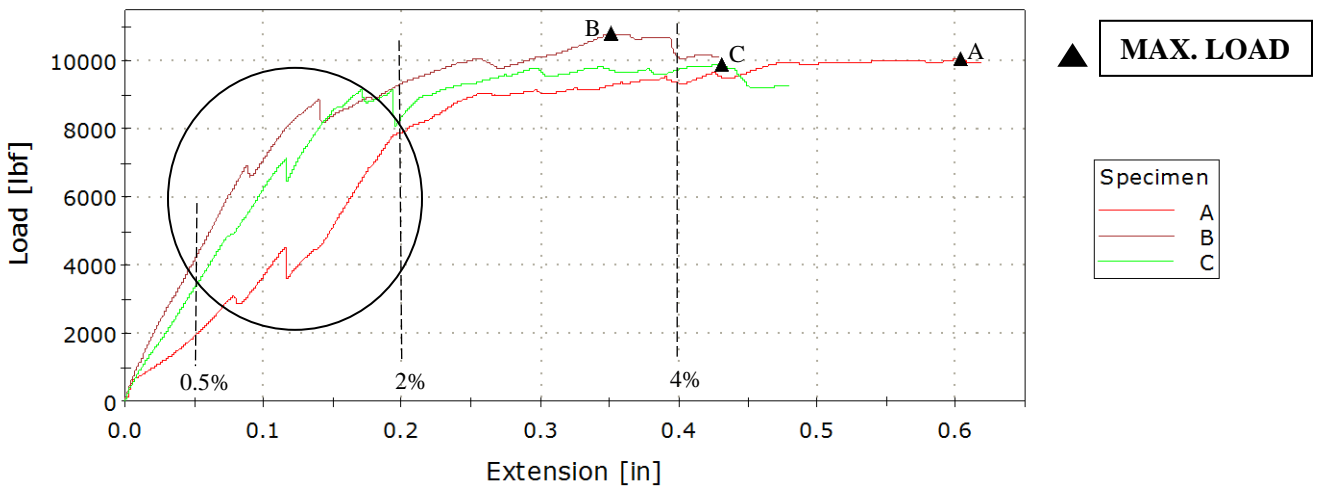
Configuration 1

SPECIMEN	MAX. LOAD: kN (Pounds Force)	LOAD AT 4% STRAIN: kN (Pounds Force)	LOAD AT 0.5% STRAIN kN (Pounds Force)	MODULUS AT 0.5% STRAIN kN/mm (Pounds Force/Inch)
A	44.80 (10,071)	41.59 (9,349)	8.54 (1,921)	6.72 (38,420)
B	48.00 (10,790)	44.89 (10,092)	18.43 (4,144)	14.51 (82,880)
C	44.05 (9,902)	43.37 (9,751)	14.68 (3,301)	11.56 (66,020)
MEAN	45.61 (10,254)	43.29 (9,731)	13.88 (3,122)	10.93 (50,914)

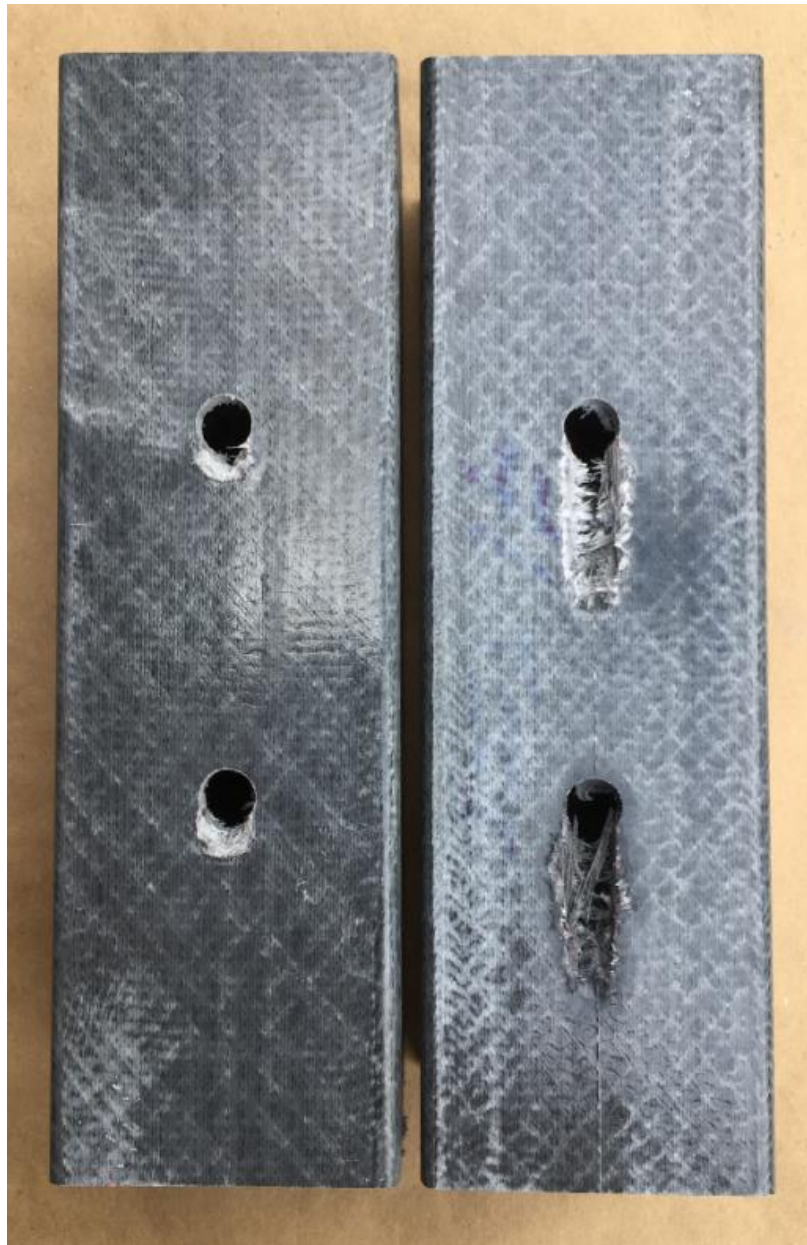
As the pictures in Figure 8 below show, the failure points are the bearing surfaces in the tubes (as predicted). The straps and bolts showed no visible deformation. These results mimic those reported in the prior noted references: Ultimate failure occurs very near the 4% elongation value at loads that are far lower than theoretically predicted. Additional loading simply tears the bearing surfaces out catastrophically. More significantly and surprisingly, however, the curves above show the bearing areas distinctly breaking down along the way to 4% elongation, notably

near the 1% and the again at the 2% elongation levels. (These were audible events during the testing.) From this testing, a case could be made that the samples actually failed when the curves began to flatten at 2% at 35.6 kN (8,000 pounds). Were these samples of metal construction (ductile in nature), they would be classified as “yielding” at this point. The modulus calculation for this configuration was done at only 0.5% strain for this reason. These values are highly varied and of questionable significance.

**4% ELONGATION POINT    FAILURE AT >4% LOAD**

**FIGURE 8 – CONFIGURATION № 1 / SAMPLE A: 44.8kN (10.0 K-POUNDS)**

The pictures in Figure 8 point to the reason that the bearings failed at less than two-thirds of the theoretically predicted levels. The predicted values assume negligible clearance and inelastic bodies, i.e., it assumes the bearing pressure is uniformly distributed. The reality, as shown in Figure 9, is that the bearing pressure is concentrated over a much smaller effective area due to the hole clearance needed for practical assembly.<sup>(29)</sup>

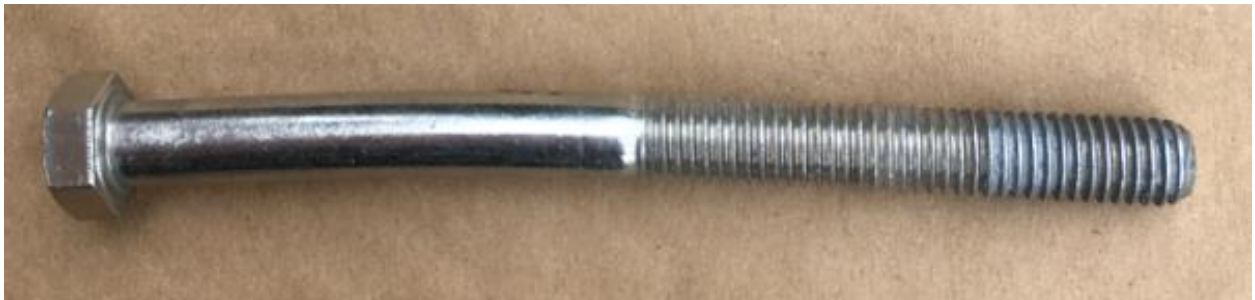
These curves show the samples behaving much more consistently and predictably with the addition of shear bushings. The bushings double the shear-bearing area and distribute the pressure more uniformly. Catastrophic tear out of the tubes was not observed. This can be seen in the pictures in Figure 10. Theory predicted the failure mode would shift to the strap and should have held to 100 kN (22,500 pounds). The mean was 70 kN (15.7 k-pounds) – 70% of the predicted value. The straps did not have the benefit of a bushing and the effect of bearing-pressure concentration in the straps (as shown in Figure 9) is the likely explanation of the deficit. The bolts also deformed inelastically, indicating that system failure is fairly uniformly distributed across all the components at this point.

**FIGURE 10 – CONFIGURATION № 2 / SAMPLE B  
17.4 K-POUNDS (77.6 kN)**

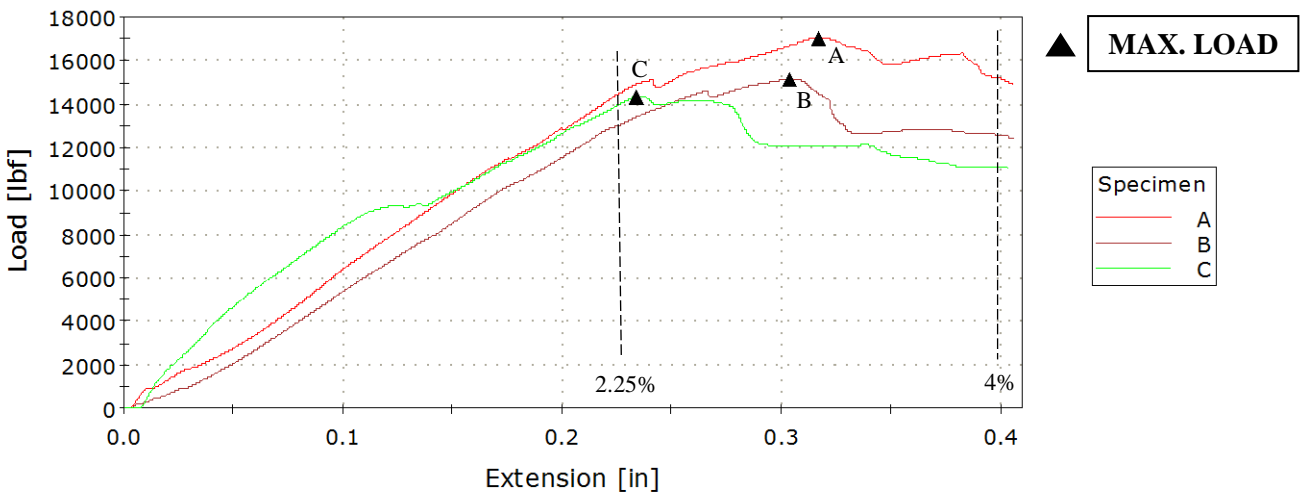
Configuration 3

SPECIMEN	MAX. LOAD: kN (Pounds Force)	LOAD AT 4% STRAIN: kN (Pounds Force)	LOAD AT 2.25% STRAIN kN (Pounds Force)	MODULUS AT 2.25% STRAIN kN/mm (Pounds Force/Inch)
A	75.76 (17,035)	67.54 (15,183)	64.16 (14,423)	11.23 (64,102)
B	67.51 (15,176)	55.85 (12,556)	61.89 (13,913)	10.84 (61,835)
C	63.65 (14,309)	49.29 (11,082)	57.70 (12,971)	10.00 (57,649)
MEAN	68.98 (15,507)	57.56 (12,941)	61.25 (13,769)	10.69 (61,195)

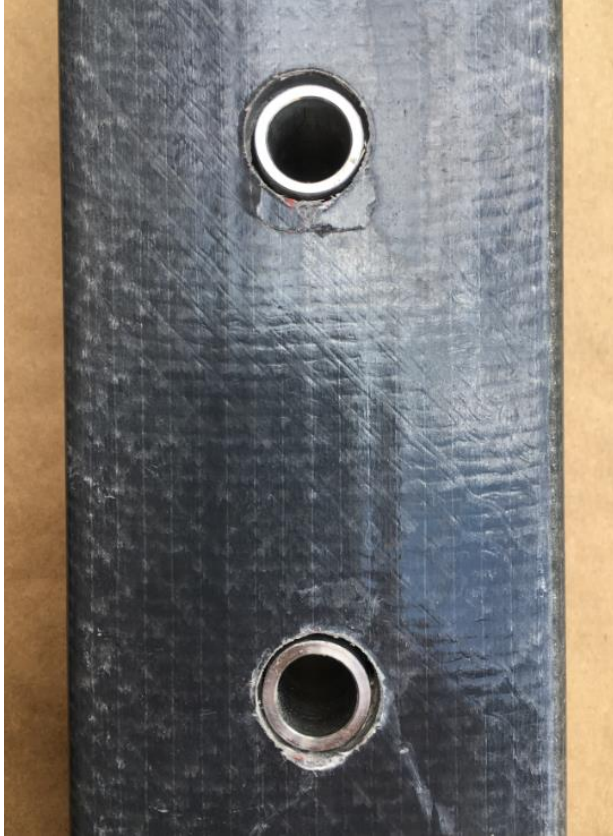
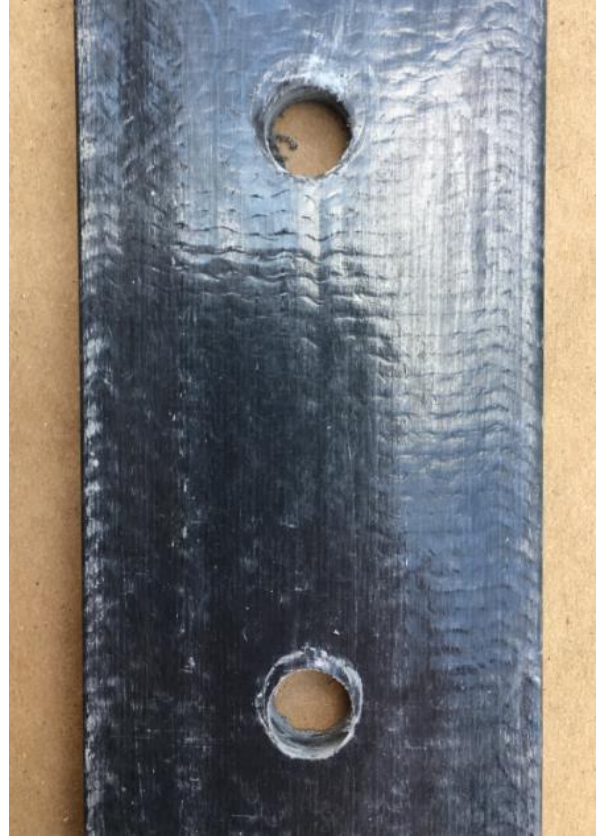
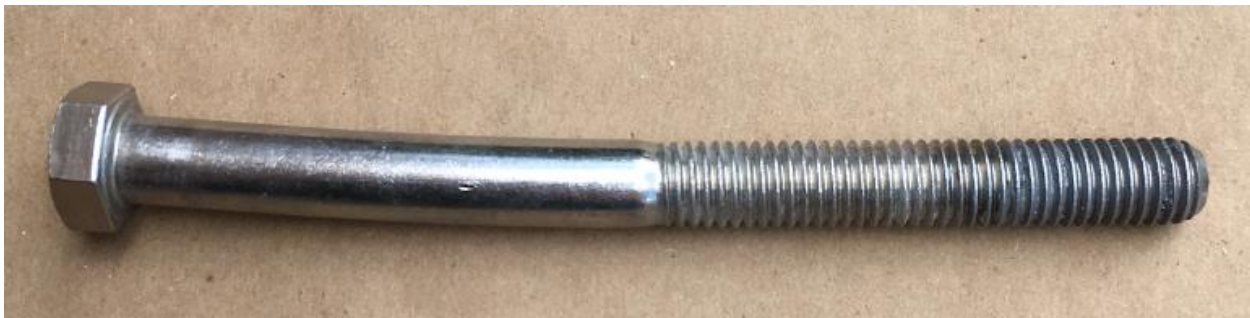
The pictures in Figure 11 again show the system uniformly failing at the tube bearing surfaces, the strap bearing surfaces, and the bolt itself. The combination of the full-length stainless-steel shear bearing and the clamped connection produced a much stiffer system – about twice that of the plastic bushing in a pinned connection. This is reflected by the system’s higher modulus. Failure occurred at approximately the same level of loading, but only at half the elongation due to the increase in system stiffness.

**FIGURE 11 – CONFIGURATION № 3 / SAMPLE A  
75.8 kN (17.0 K-POUNDS)**

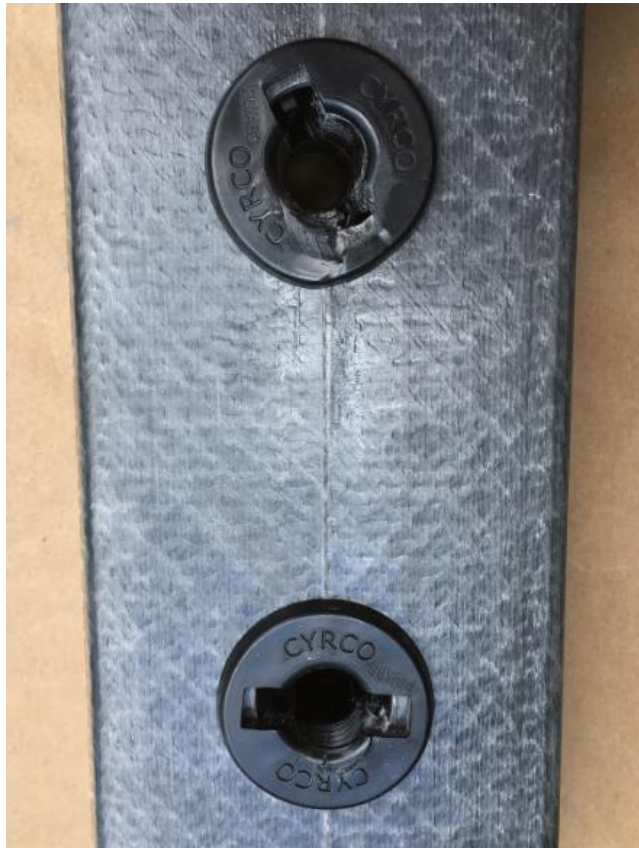
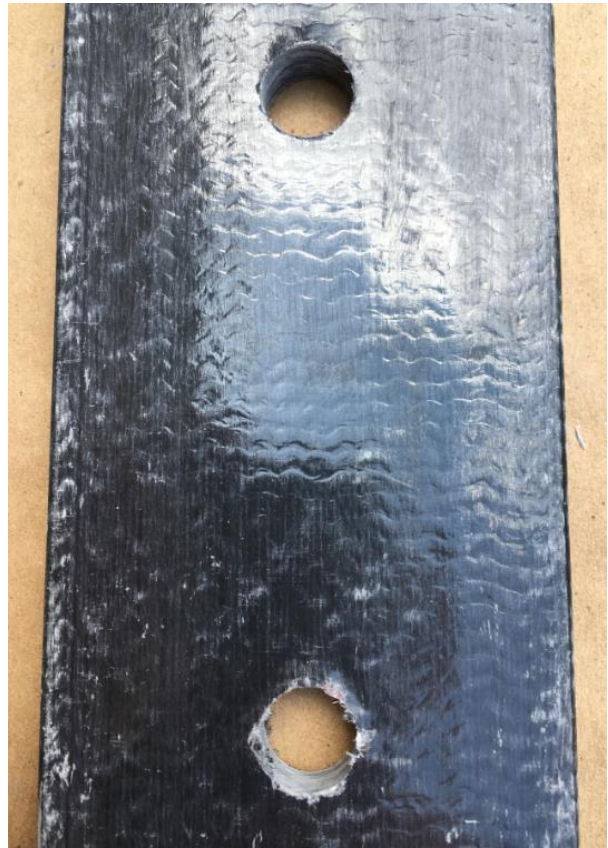
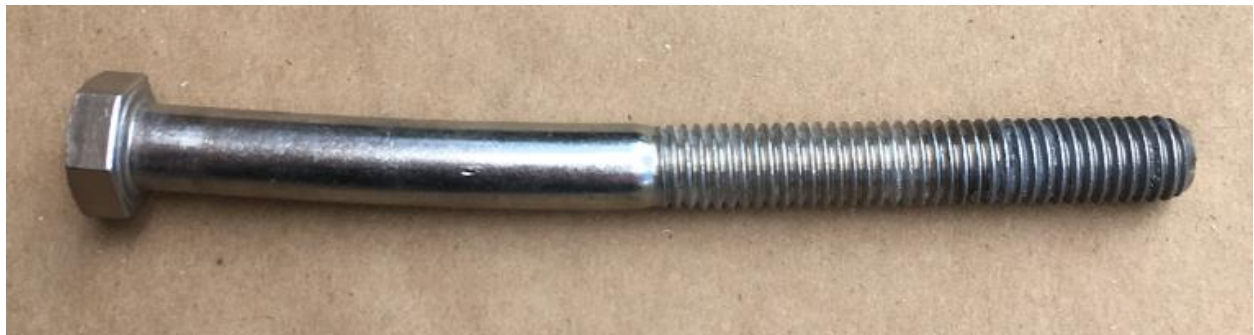
Theoretically, there should not be a significant performance difference between Configuration № 2 and № 4: Both are Ø25.4 mm (Ø1”) shear bushings treated as pinned connections. However, these test results show № 4 produces about 12% higher ultimate strength than № 2 and elongates about 20% further before ultimate failure. This is likely due to the advantage of the larger diameter and thickness of the flanges to distribute the loading, as previously predicted in References 7 and 8.

**FIGURE 12 – CONFIGURATION № 4 / SAMPLE C  
80kN (17.5 K-POUNDS)**

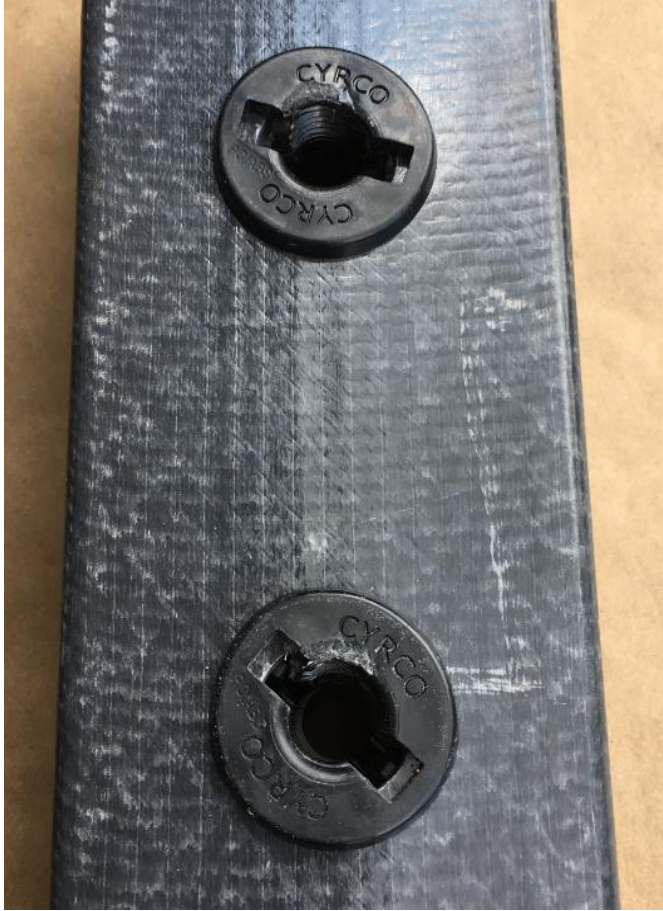
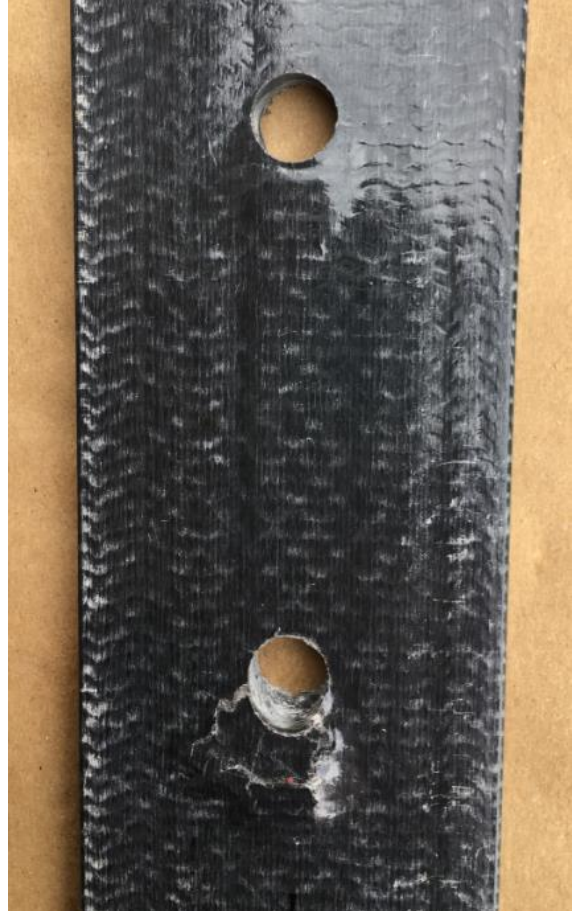
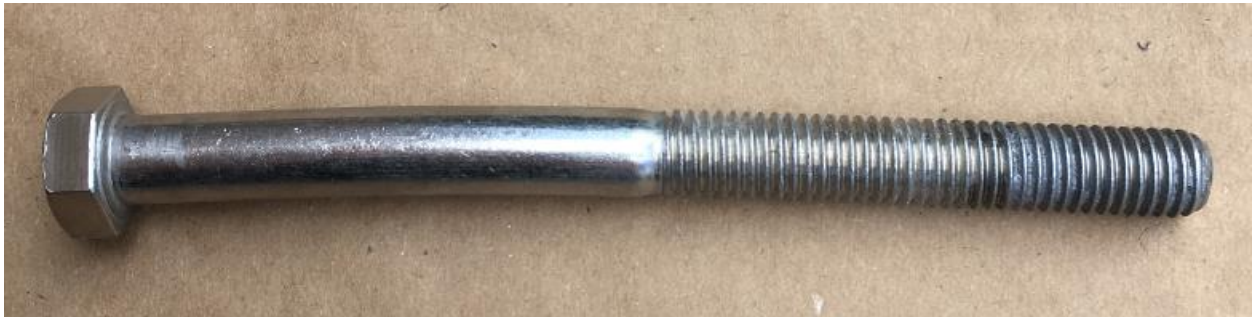
**FIGURE 13 – CONFIGURATION № 5 / SAMPLE B  
85.3kN (19.1 K-POUNDS)**

Just in terms of ultimate tensile strength, as theory expected, there was not a significant difference between the pinned of Configuration № 4 and the tightly bolted connection shown here. The failure modes uniformly included the bearing surfaces in the strap and the bolts. The difference between Configuration № 4 and № 5 was expected in joint stiffness, as evidenced by overall system modulus. The tightly-bolted connection did show about an 8% increase in system modulus at 4% strain.

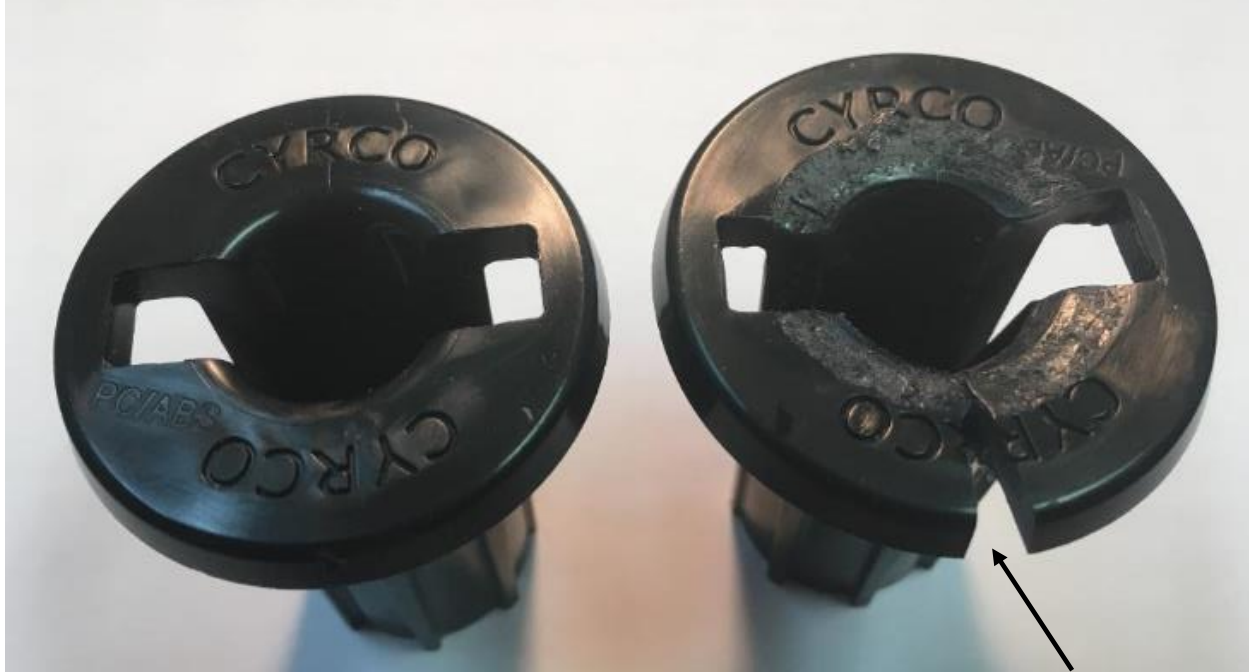
FLAT WASHER IS DRAWN INTO BUSHING, CAUSING CRACK TO DEVELOP IN FLANGE

**FIGURE 14B**  
**COMPRESSION OVER-STRESS TEST**  
**84 N-M (62 FT-LBS) TORQUE**
